Manhole Inspection Summary

Manhole # S23KK_038MH

Insp Date: **7/5/05 6:52 PM**

Location Address: **2400 DRUID HILL AVE**

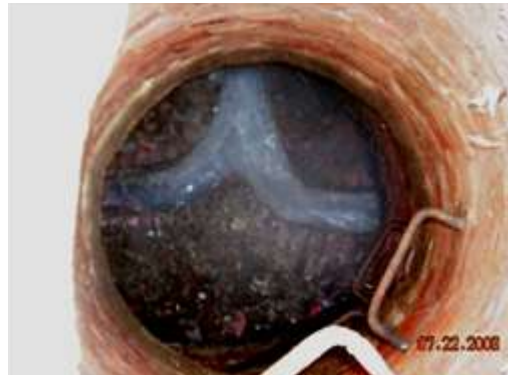
Top View

Corroded steps. Evidence of surcharge - Bench debris.

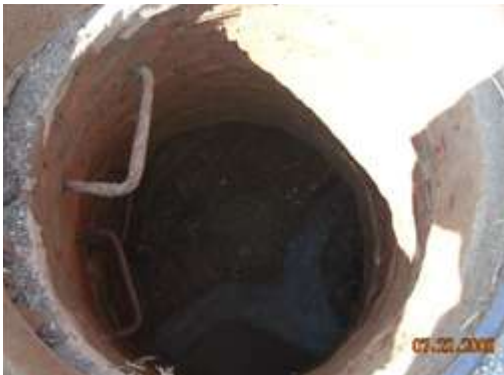
Defect

Frame leaks. Frame offset. Adjustment deterioration and infiltration. Barrel infiltration - other side.

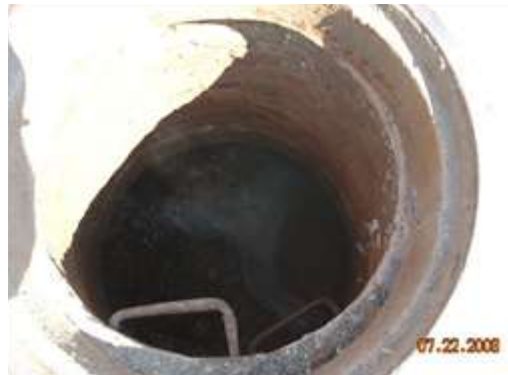
Defect

Frame leaks. Frame offset. Adjustment deterioration and infiltration. Barrel infiltration.

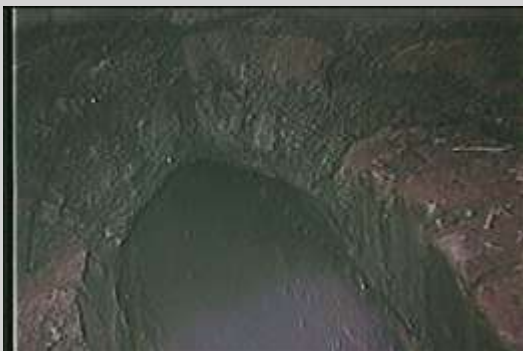
8 in. Circular Gravity Sewer Pipe In @ 3 O'Clock

Infiltration: **None** Pipe Seal Cond: **Broken**
